Accessibility Assessment Report

Location: Milnathort

Date: 3rd of December 2025

An Accessibility Assessment was conducted to evaluate the accessibility of the streets around the Town Hall.

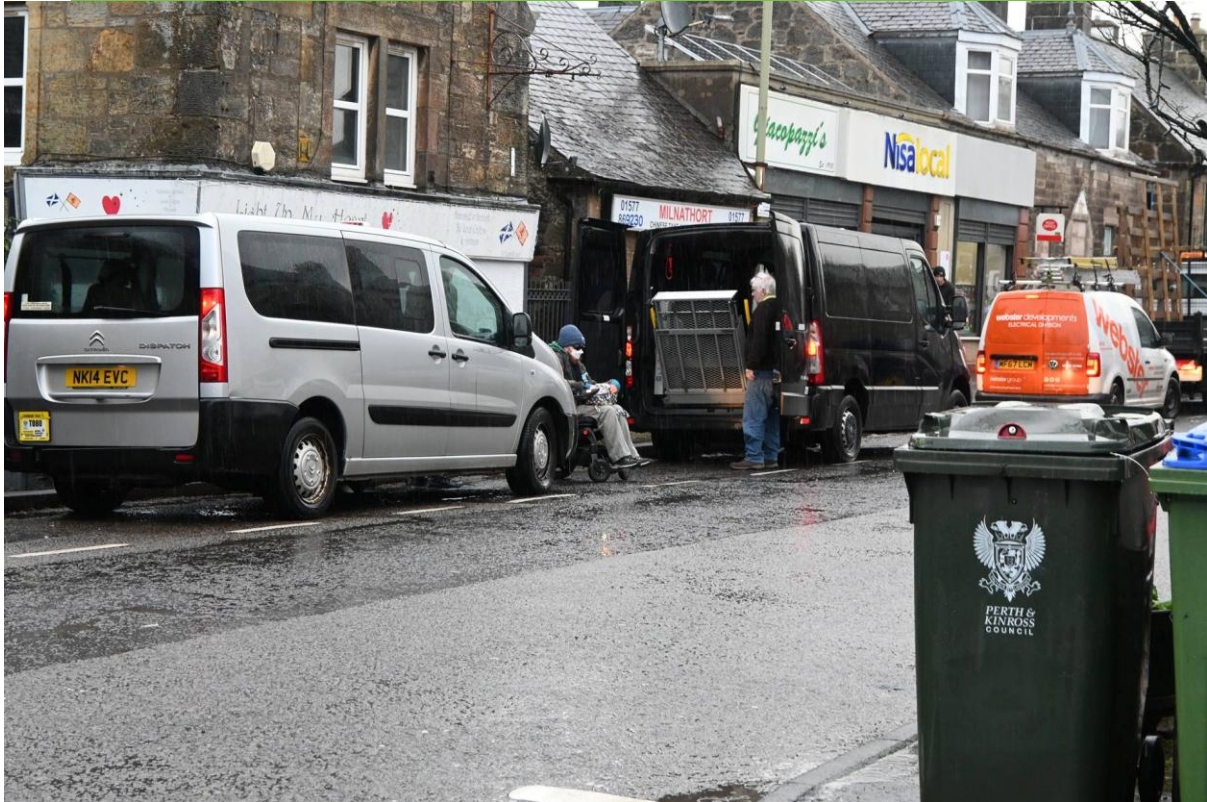
The photo above shows Evander disembarking from the taxi at the parking bay on the main street. There was a double kerb at the left of the bay. A wheelchair user would have to cross over the road to reach the pedestrian crossing to then cross back again to reach the Town Hall. There was no clearly marked area for drop off.

Access from the taxis to the meeting point at the town hall was tricky due to the raised pavement at the parking bays. The wheelchair users had to disembark from the vehicles and cross the road diagonally to

reach the pedestrian crossing. The path around the town hall has a cobble style texture with a slope which was tricky to manoeuvre.

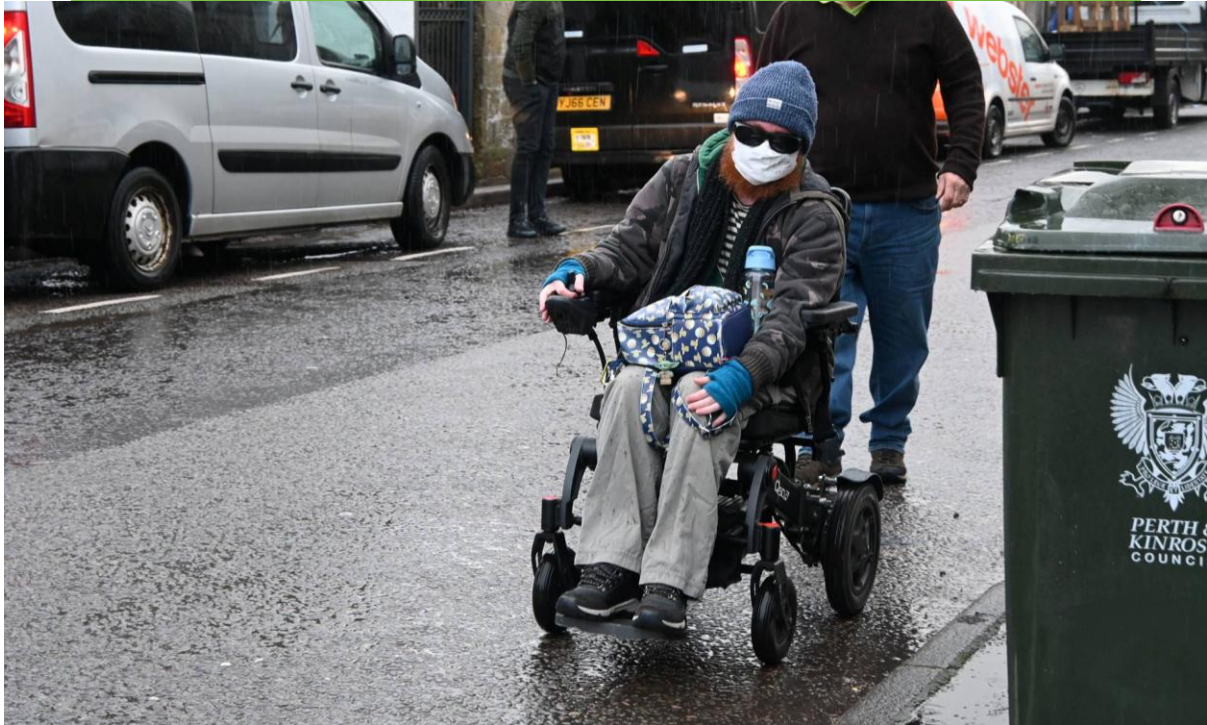
The photo above shows Evander navigating his way from the taxi in the parking bay to get to the pedestrian crossing to then cross back over the road to the town hall.

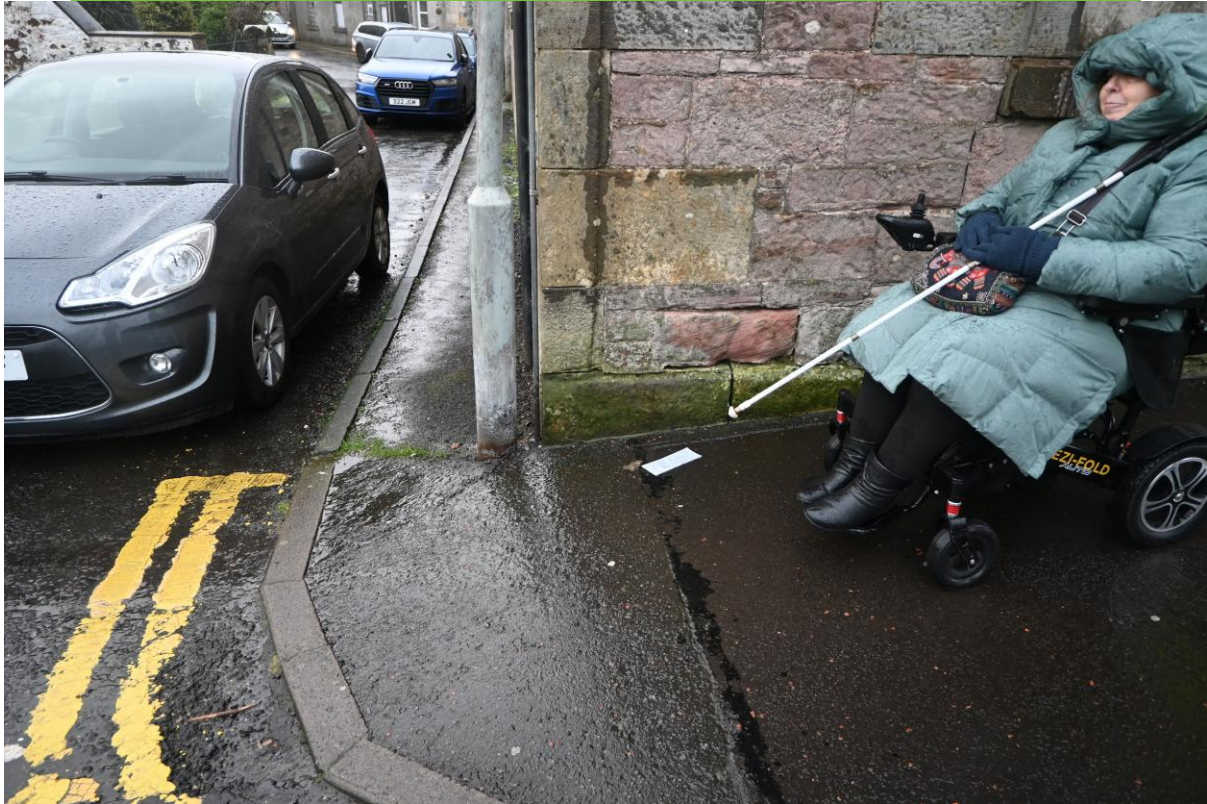
The photo above shows Cindy navigating the pavement before crossing a side road. The path has a steep gradient which was difficult for her chair to navigate. The parked car was very close to the dropped kerb.

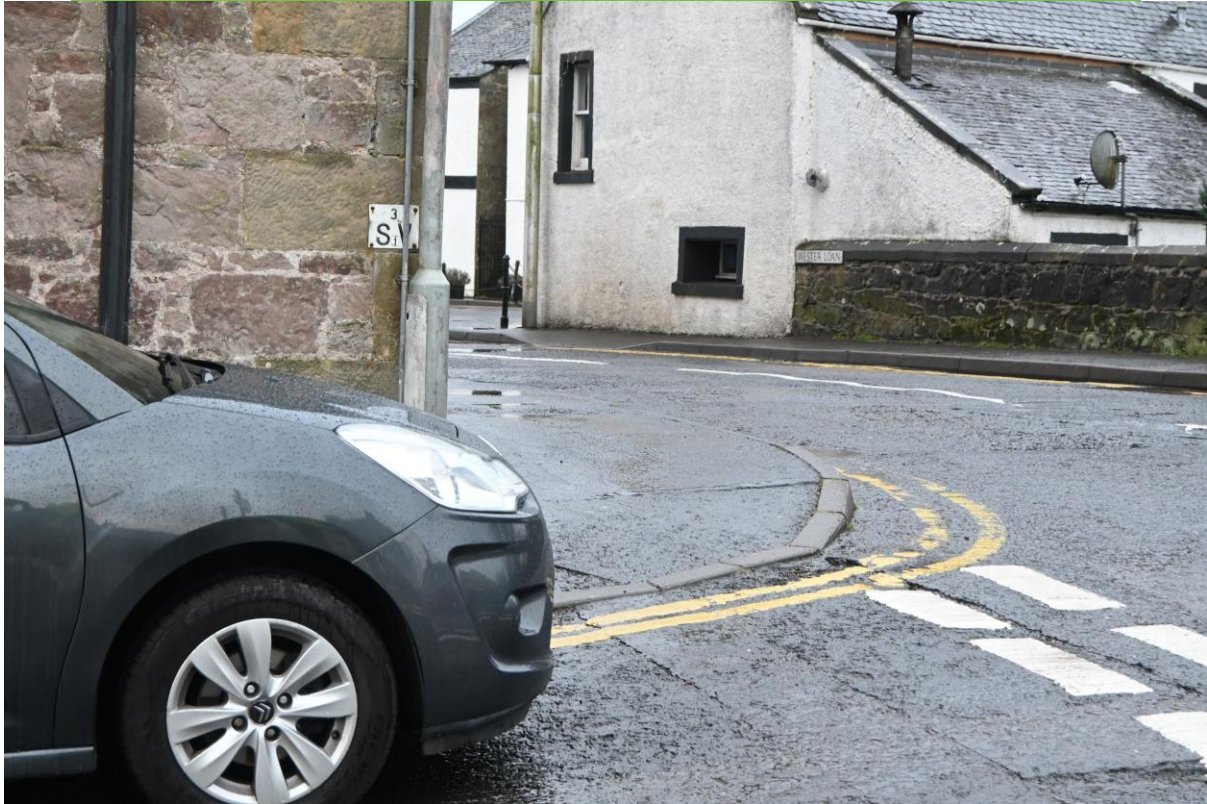
The photo above shows the dropped kerb and parked car which is very close to the junction. The car was parked behind the yellow lines and so to make an improvement, the yellow lines could be extended.

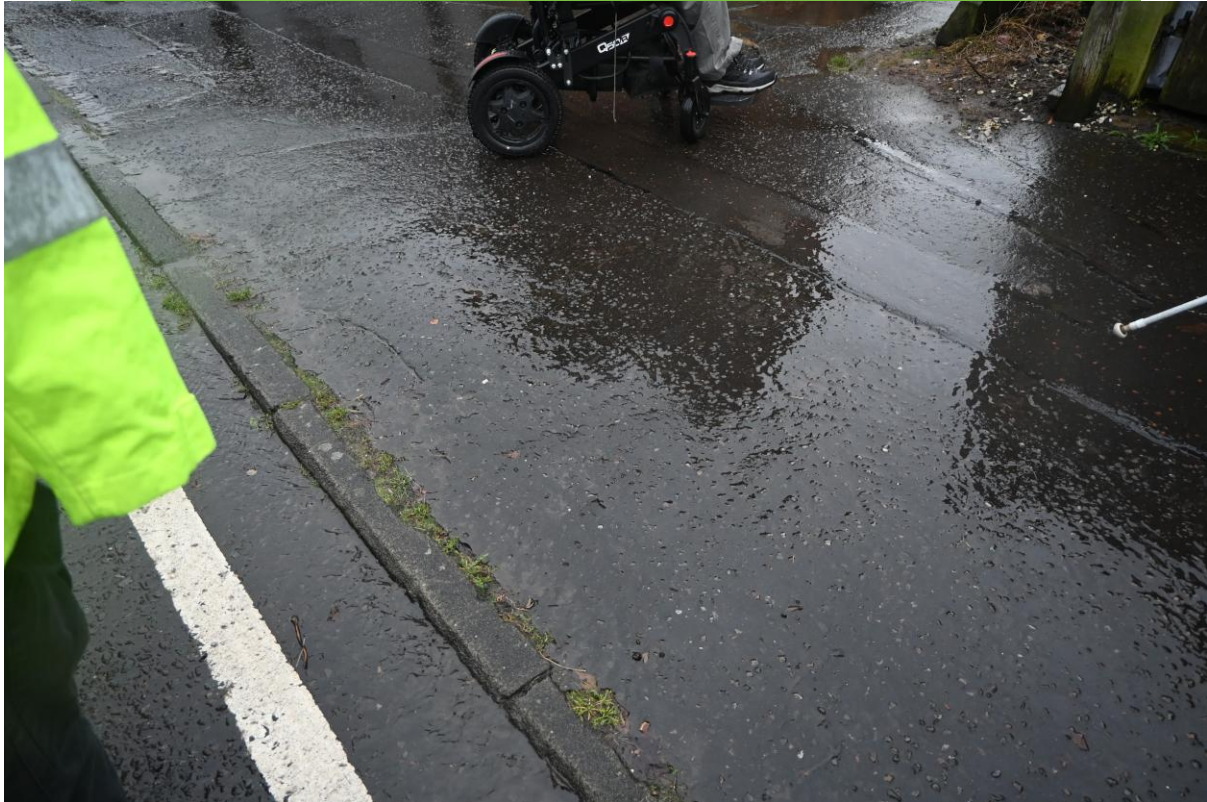
The photo above shows one of the dropped kerbs. As the kerb was not flat, one of the wheelchairs struggled to manoeuvre over it. We noted that it was easier driving down onto the road however, driving up and onto the path proved tricky.

Overall, there were few dropped kerbs where they were needed and the dropped kerbs that were in place, were not flat.

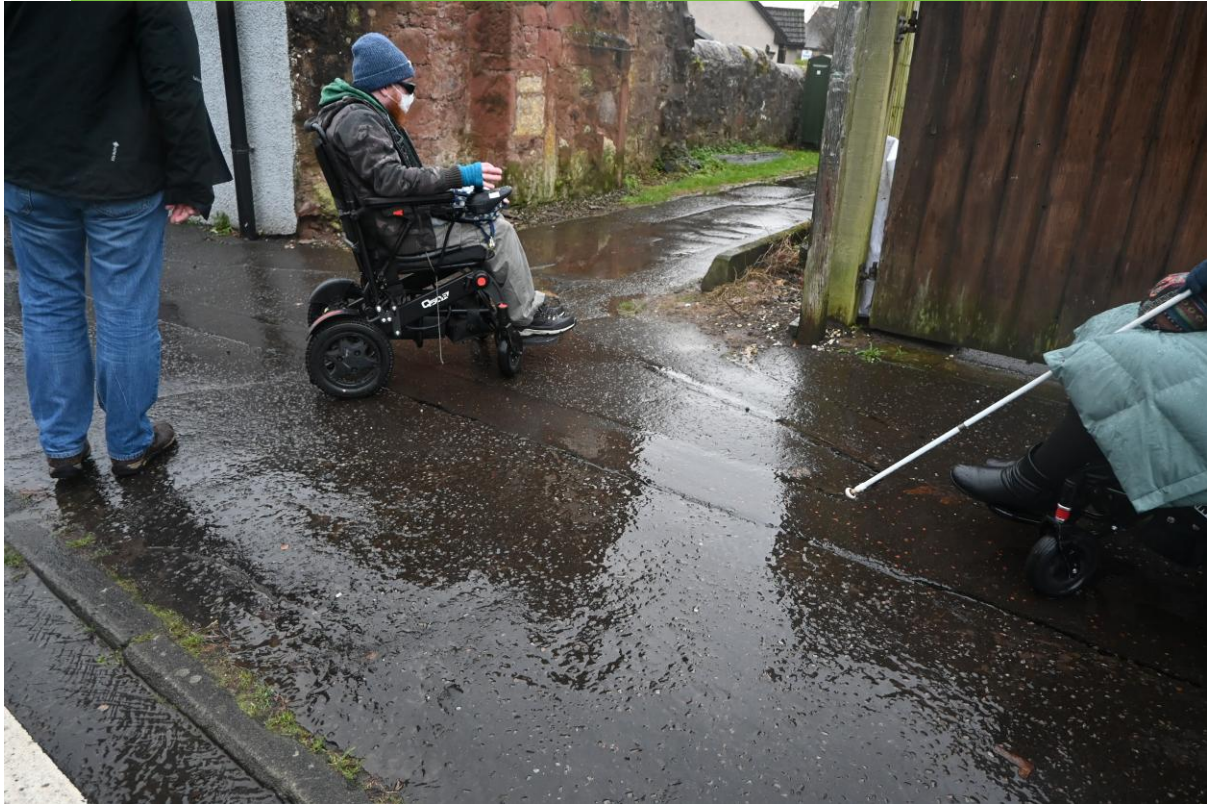
The photo above shows the entrance to one of the paths we explored.

The path surface was mostly smooth.

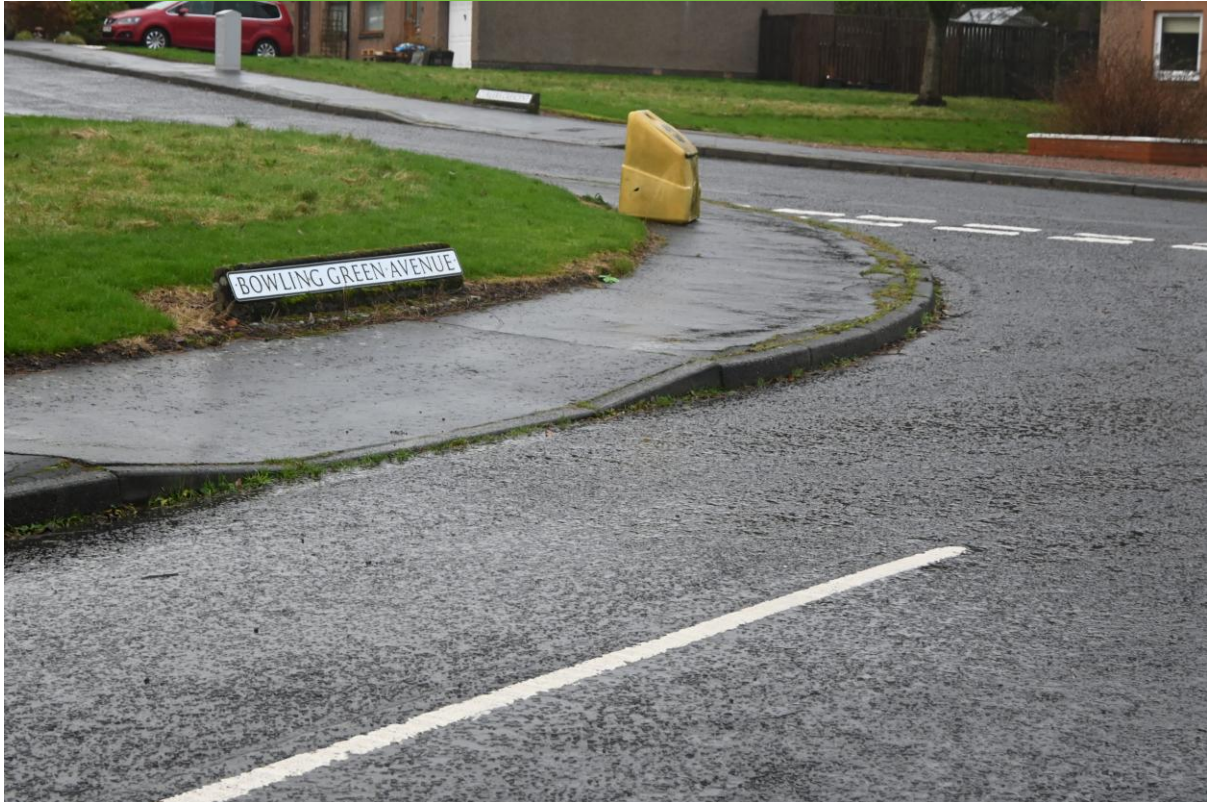
The photo above shows a dropped kerb which proved suitable for both wheelchairs to drive on to the road however proved to be tricky to drive onto the path for one of the wheelchairs. Further discussion with one of our members highlighted that kerbs tend to be more difficult to negotiate for lighter weight wheelchairs.

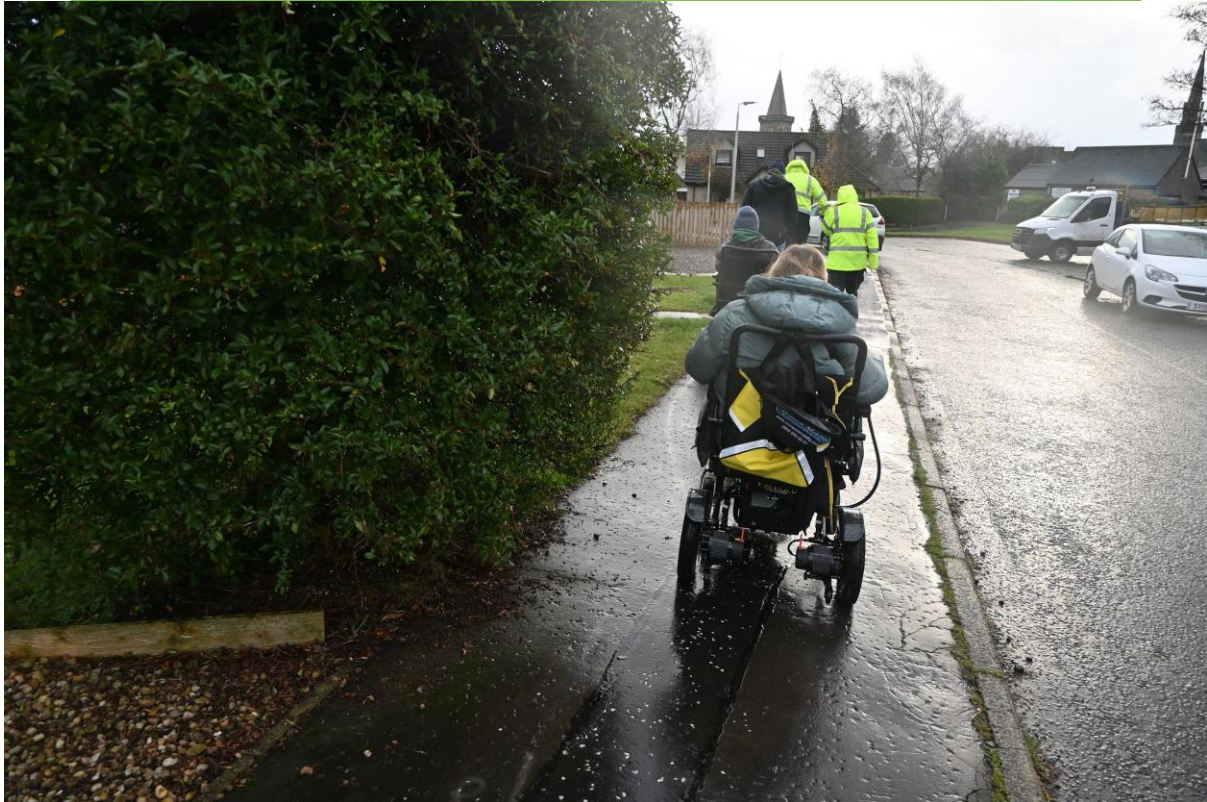
The photo above shows the group navigating one of the paths at a residential area. The path slopes to the right and a bush on the left hangs over the path. On a dull day the dark, green bush was not noticeable for a person with a peripheral visual impairment. The gradient of the path meant that the wheelchair felt like it was tipping.

Both wheelchair users commented on the camber of the paths around the route we explored as they found the same issues with most of the paths.

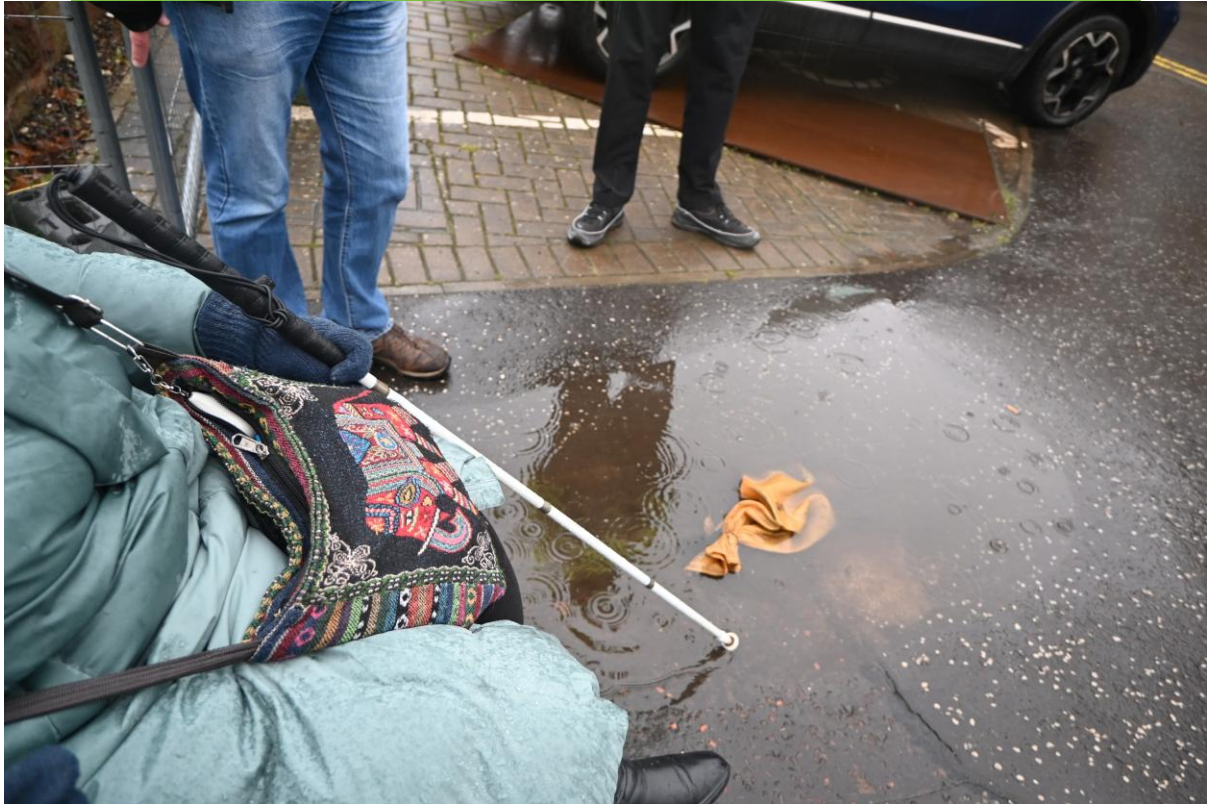
One of the paths had a sandbag positioned in a puddle of water. This proved hazardous for one of our wheelchair users as the sandbag was in the middle of the path.

The photo above shows a sandbag placed in the middle of the path. The sandbag had been placed in a hole or dip. It was partially submerged. One side of the wheelchair caught on the sandbag and could have caused further issues if the wheelchair user was unaccompanied. On this occasion, the wheelchair tipped however, the user was able to stop themselves from falling as they had the use of their left leg.

It was unclear why the sandbag was placed on the path.

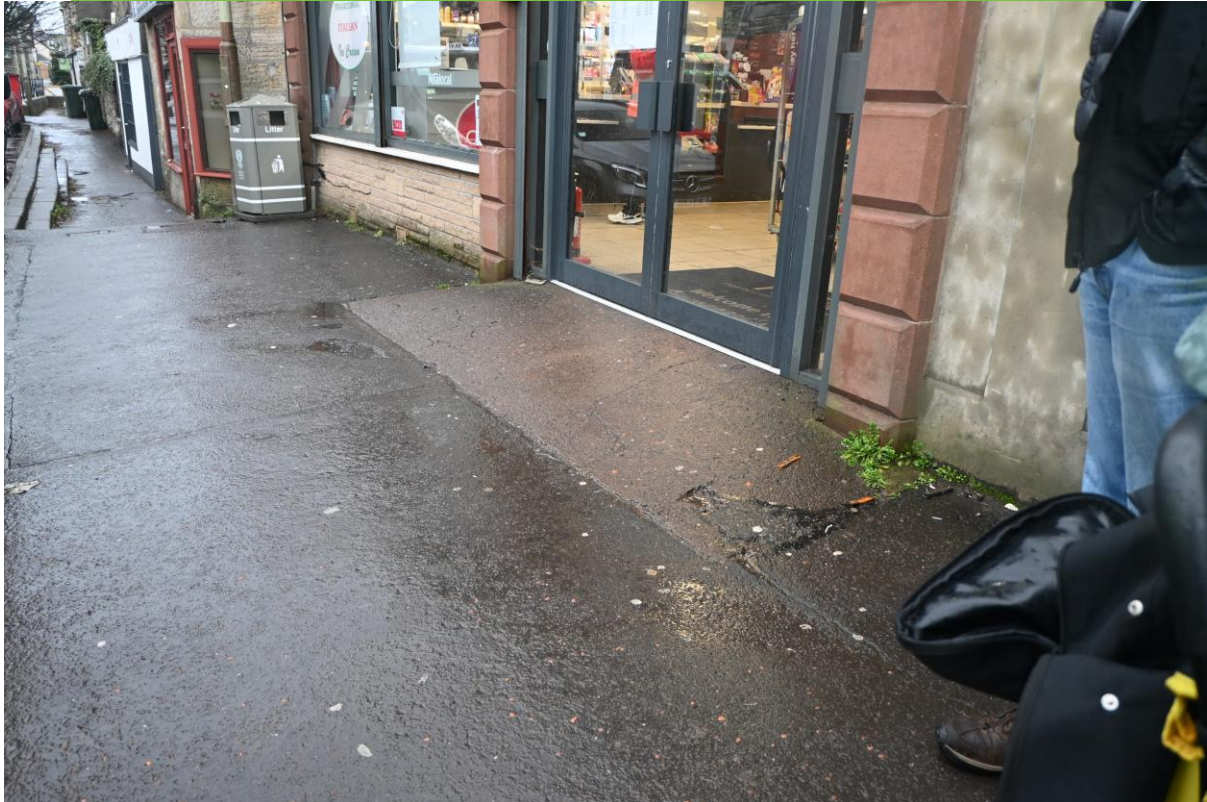
The photo above shows a change in gradient on the path at the shop entrance. The gradient appeared quite steep for a wheelchair user to navigate. The lack of colour contrast presents a hazard for people with sight impairments. We suggest that white or yellow paint could be applied around the section at the doorway. Ideally, reducing the gradient would make the entrance more accessible.

Outside the Nisa store, there was a steep section of paving at the entrance. A painted line around the section would help to indicate the difference in gradient.

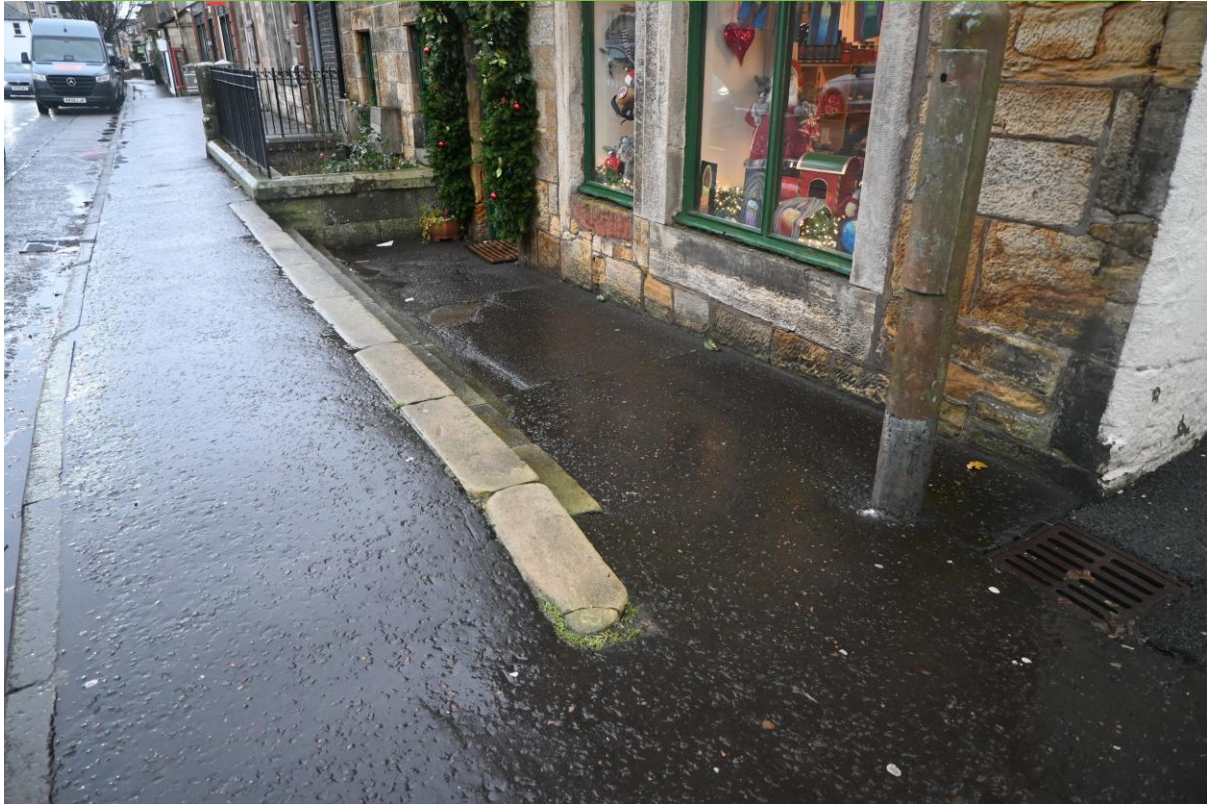
The photo above shows steps at the side of a path in front of a shop. The path is fairly narrow and one of our wheelchair users did not notice that the change in path was actually steps. Painted lines or a barrier would help to improve safety for people with disabilities using the path.

Steps at the side of the path near shops proved to be hazardous as there was no line to indicate the drop from the path. There was no barrier to prevent a wheelchair from tipping down the steps.

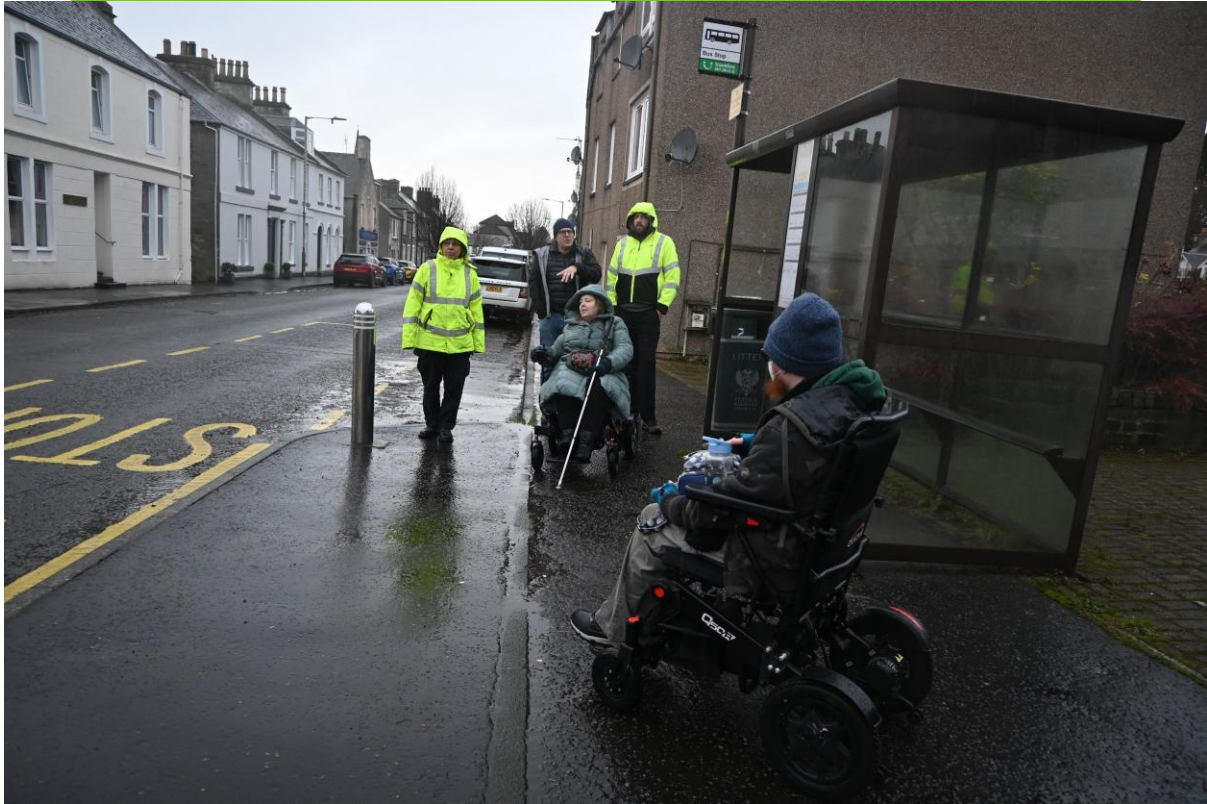
The photo above shows the path where the bus will stop. The group discussed improvements and agreed that providing bus drivers have an awareness of passengers' needs and also use the drop down ramp on their vehicle, there should be no issues. The extended path is helpful for passengers to manoeuvre.

The group viewed two bus stops on the main road and discussed possible improvements such as line painting which would indicate where the buses should stop to allow for easier access.

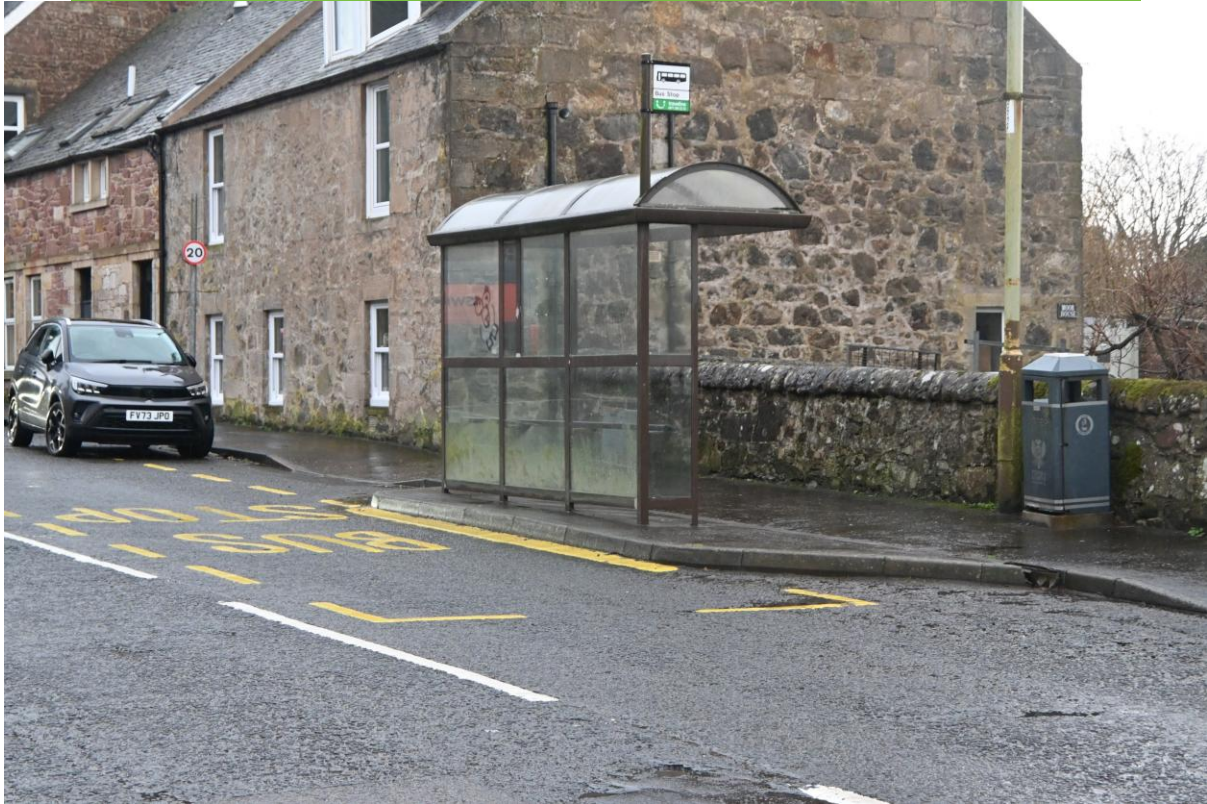
The photo above shows another bus stop.

The group did not have any suggestions for improvements other than to revisit and observe passengers using the area.
